TECHNICAL NOTE

No. 1235

AN INVESTIGATION OF A THERMAL ICE-PREVENTION SYSTEM FOR A  
CARGO AIRPLANE. VIII - METALLURGICAL EXAMINATION OF THE  
WING LEADING-EDGE STRUCTURE AFTER 225 HOURS OF FLIGHT  
OPERATION OF THE THERMAL SYSTEM

By Maxwell Harris and Bernard A. Schlaff

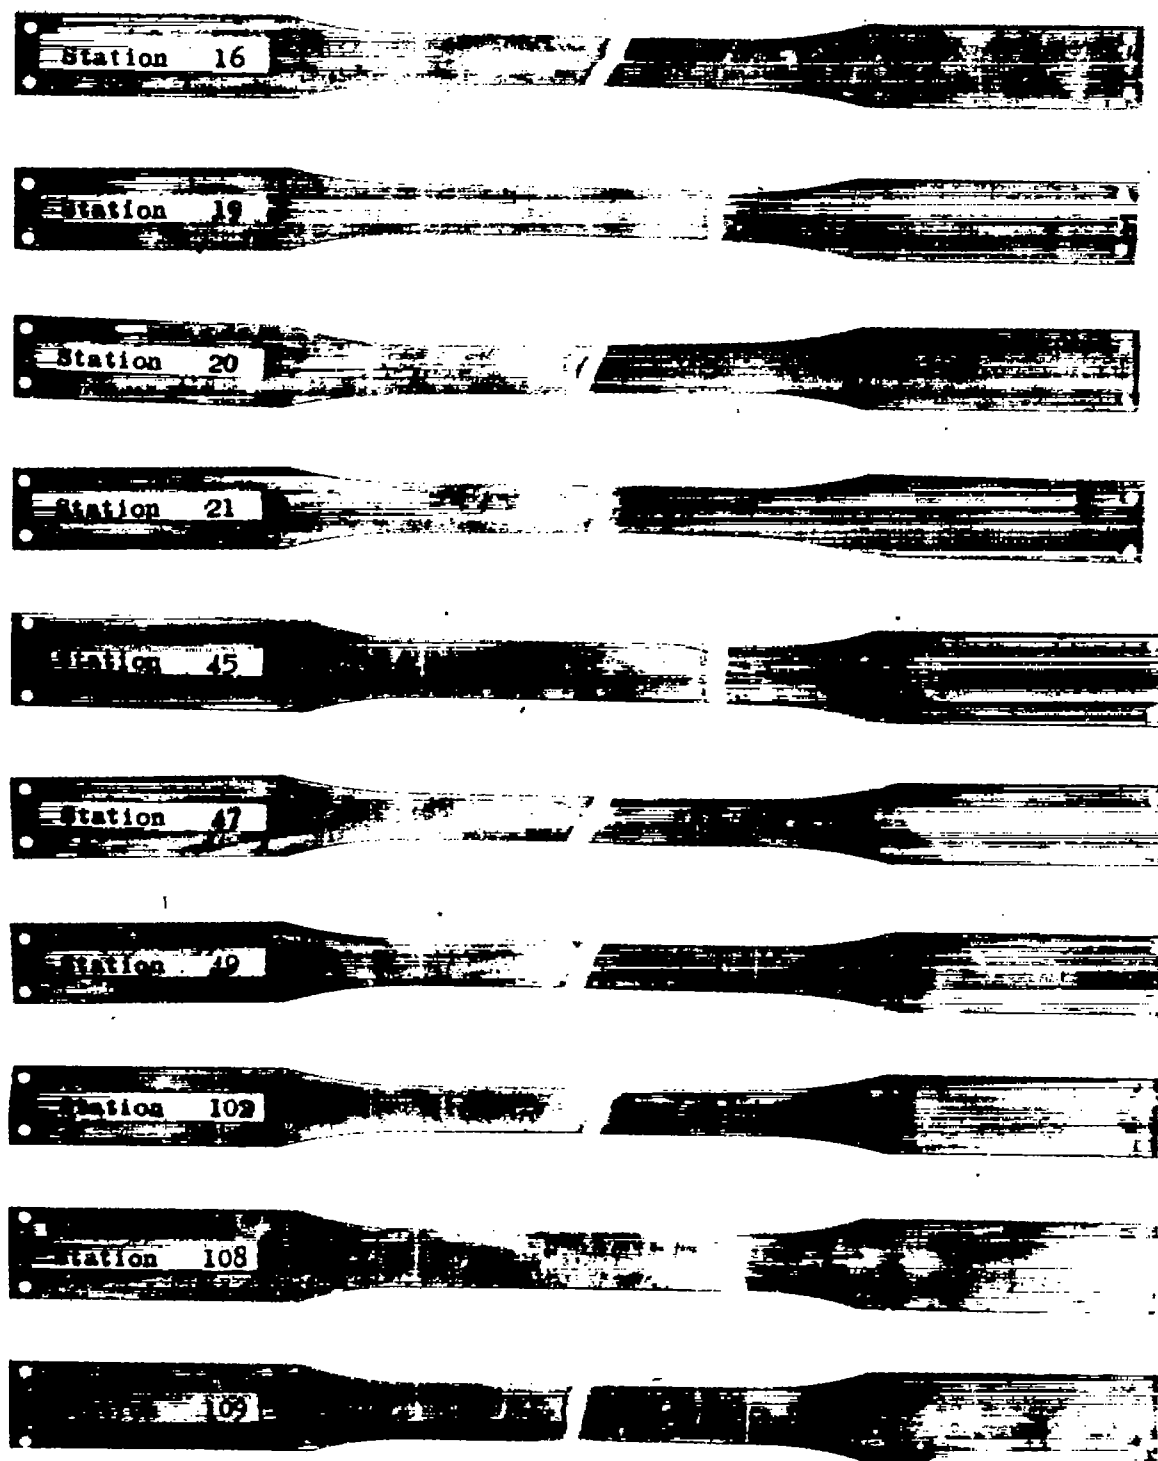
Figure 11.- Alclad 24S-T tensile specimens, taken from the baffle plate of the C-46 airplane wing thermal system, after fracture.
